Impacts of volcanic ash on surface transportation networks: considerations for Auckland City, New Zealand

A thesis submitted in partial fulfilment of the requirements for the degree of

Doctor of Philosophy in Disaster Risk and Resilience

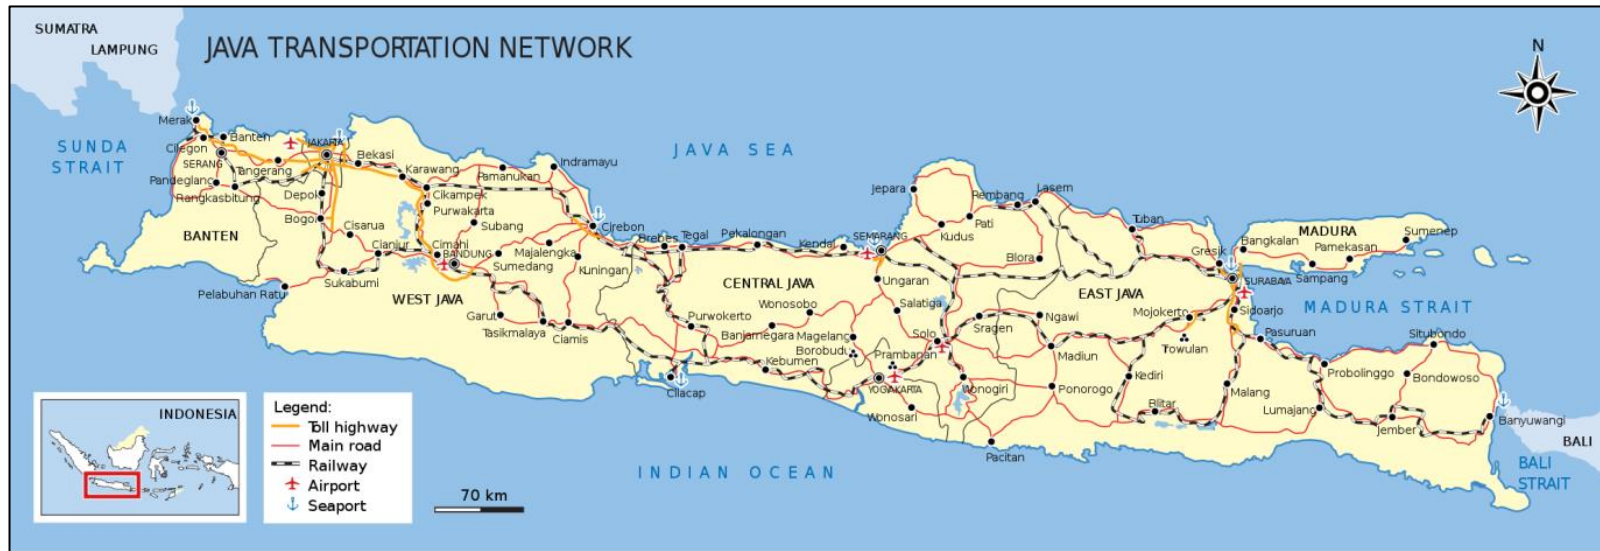
Figure 2.2 Major transportation routes of Java (Mau Ke Mana 2014).

The road, rail and domestic airline network (Figure 2.2) are used extensively throughout Java, with key shipping ports for connections to other Indonesian islands located mainly on the northern coast. A wide variety of vehicles are used for road transport. Buses operate within and between the larger cities with minibuses servicing many of the smaller towns. Motorbikes are by far the most popular vehicle in Java (71% of motor vehicles in 2003; World Bank 2013) with many adapted to transport a variety of goods in addition to passengers (Figure 2.3). Taxis and cycle rickshaws, called *becak* are common in

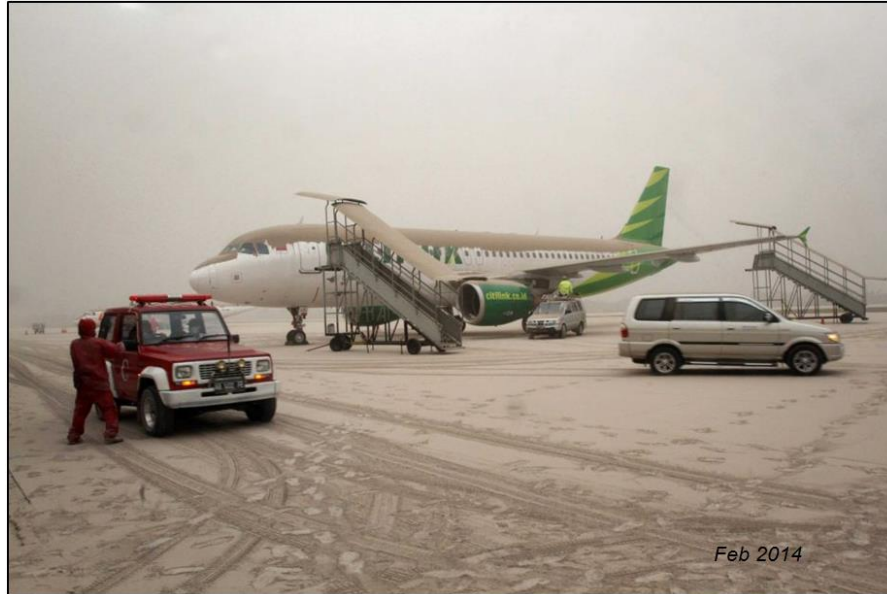
Figure 2.9 Aircraft covered in ash on 14 February 2014 at Adisucipto International Airport, Yogyakarta (ABC News 2014b).

It was estimated that 20-50 mm of ash fell at AIA following the eruption of Kelud (DJPU 2014, Jakarta Post 2014a). As the ash started falling at ~03:00 WIB and the normal opening time of the airport is at 04:00 WIB, the decision was made to not open AIA to passengers at all on 14 February. People arriving at the airport were told that it was closed which led to traffic congestion in the area (DJPU 2014*). The airport is used for both civilian and military purposes with a taxiway for each. Military planes are kept in hangers and did not come into contact with ash. At least two commercial planes however, were outside for the night of the 13 February (e.g. Figure 2.9) and ash infiltrated into the engines of the stationary planes despite being covered by plastic sheeting at some stage. Subsequently, the engines required dismantling, deep-cleaning and complete oil changes – a very expensive process which required specialist technicians (DJPU 2014*). The Directorate General of Civil Aviation reported that there were no indications of any damage to paintwork on the two stranded planes or to airfield surface line markings resulting from the ash.*

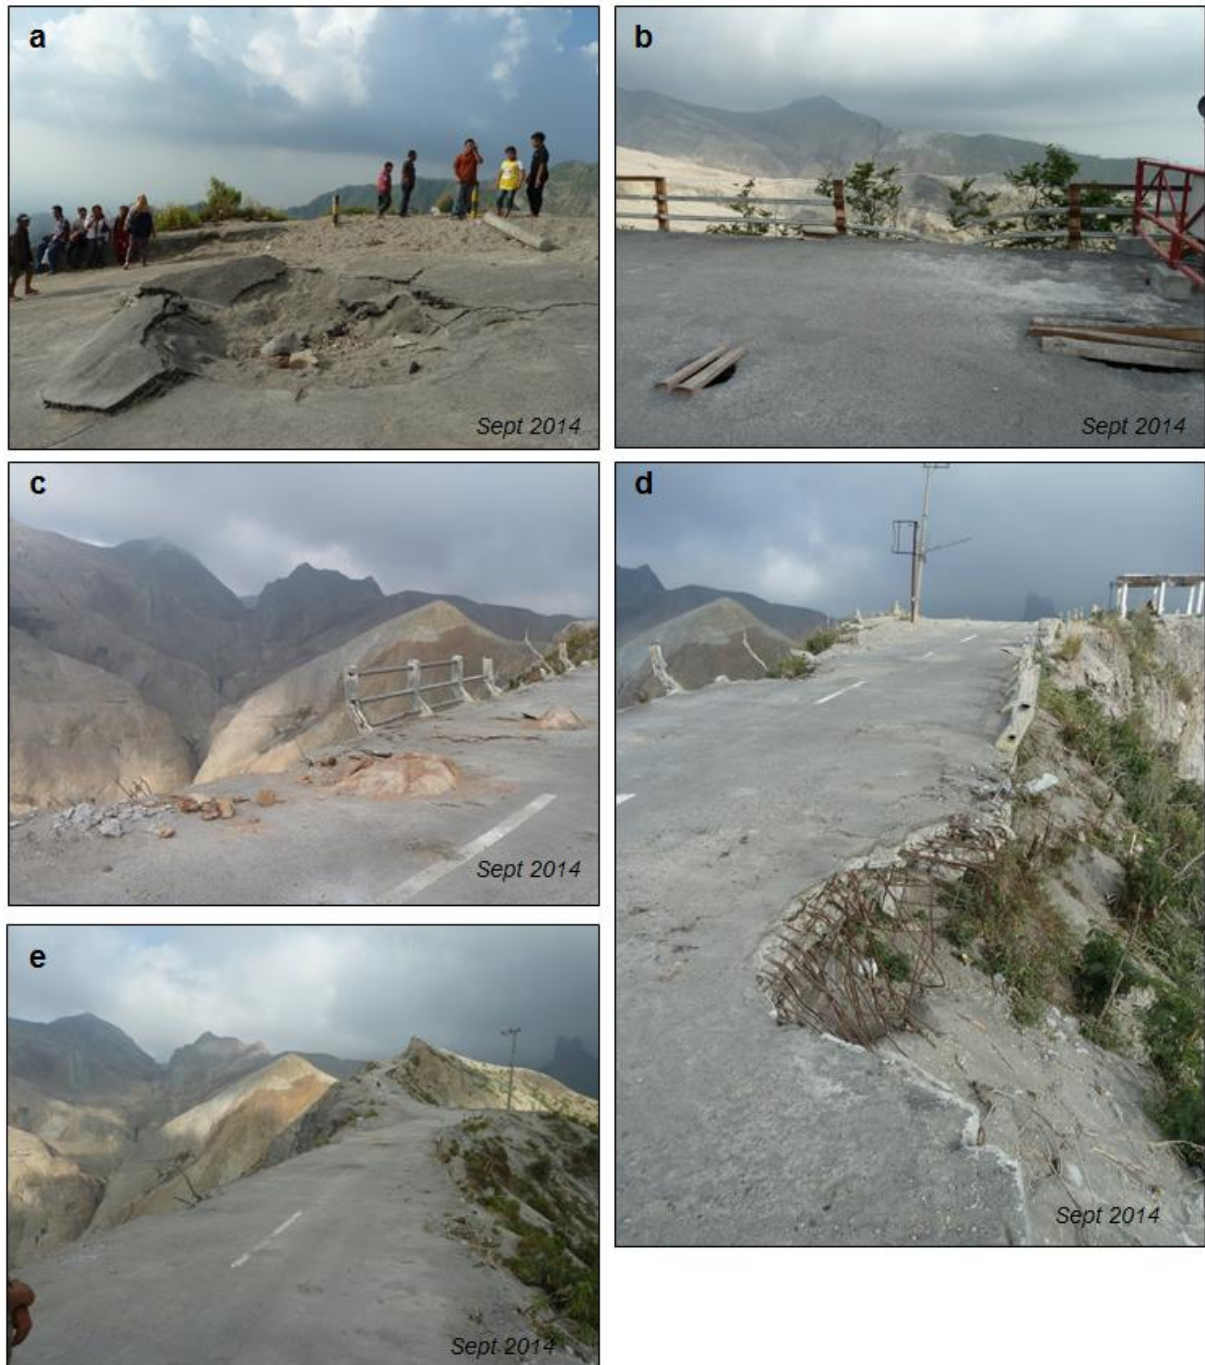
Figure 2.10 Road and bridge impacts within ~2 km of the crater (taken 20 September 2014). (a) large ballistic impact crater in asphalt concrete road surface (3.6 m along the longest axis). (b) holes in asphalt concrete and reinforced concrete bridge (now covered in wood) after being penetrated by ballistics. (c) ballistics embedded within bridge surface and damage to edge of bridge. (d) bridge structure and railing damage. (e) remaining section of the road near the crater, now cleared of ash.

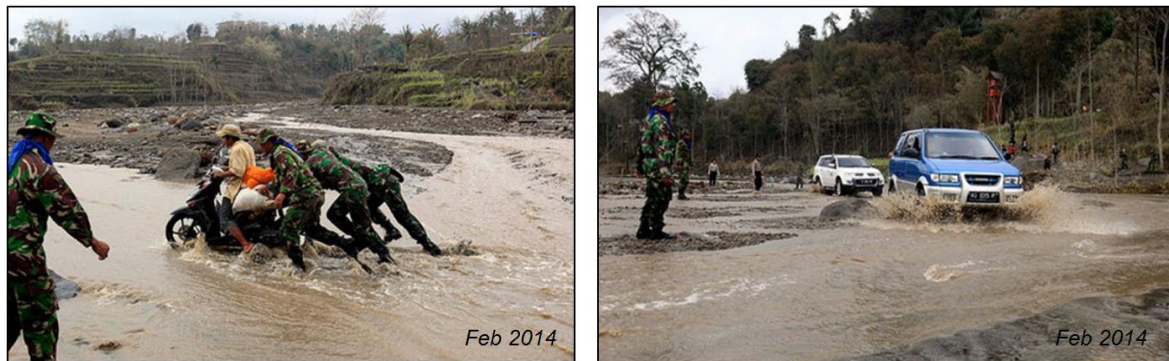
Figure 2.11 Kostrad TNI-AD (the Strategic Reserve Command of the Indonesian Army) help vehicles cross the Sambong River at site of old bridge between Munjang Hamlet and Selorejo Dam on Wednesday 19 February 2014 following a lahar (Haryanti 2014). The bridge at this site had yet to be rebuilt as of 21 September 2014.

Around 9 km NE of the Kelud crater, at least two bridges crossing the Sambong River were destroyed by a lahar. This lahar may have occurred as soon as 18 February 2014 (BNPB 2014) four days after the eruption, immediately forcing the closure of some roads (Pitaloka 2014). The bridge to the north east of Munjang Hamlet, which was frequently used by its residents and also used in the evacuation,

was ~10 m long and was of standard concrete and metal construction with an asphalt concrete deck. Seven months after the eruption, this had yet to be rebuilt and vehicles were driving on the now wider and aggraded riverbed to cross the river here (Figure 2.11). The bridge, of similar construction style, adjacent to Klangon Village was ~35 m long (Selorejo 2014*). Within ~2 weeks of being destroyed by a lahar, it was replaced by a small bamboo bridge (Figure 2.12 a) allowing residents to cross the river either by foot or motorbike. This was subsequently replaced by a more substantial bridge on loan from the Indonesian Army (Figure 2.12 b) which took 6-7 months to install, enabling easy access for all vehicles to Klangon. This larger bridge will be replaced with a new permanent bridge when the government has funds (Klangon 2014*).

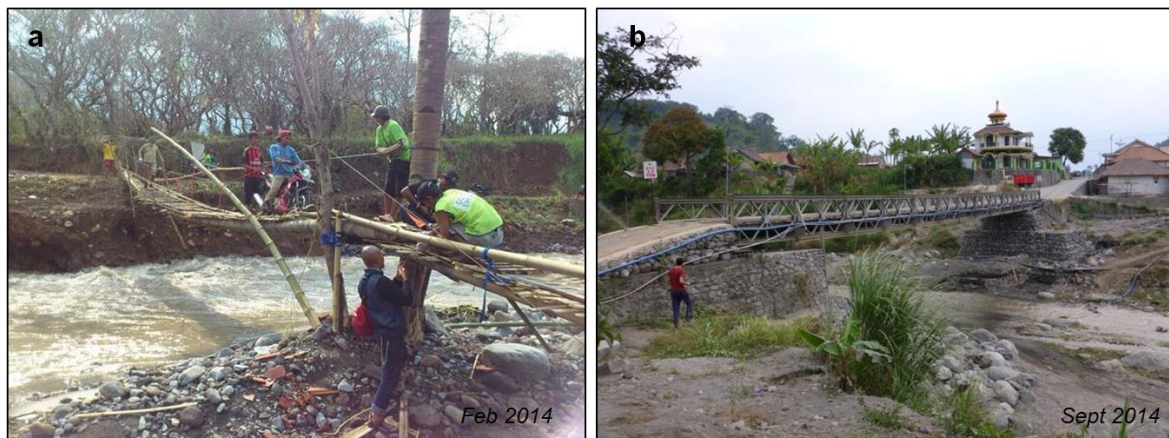
Figure 2.12 Sambong River crossing near Klangon Hamlet, Pandansari Village. (a) Temporary bamboo bridge over the Sambong River built ~2 weeks after the lahar and improving access for pedestrians and motorbikes to Klangon Hamlet (Adonai 2014). (b) Larger temporary army- bridge built nearby ~6-7 months after the lahar (photo taken on 21 September 2014).

The Sambong River (Figure 2.12) is a tributary of the larger Konto River, which was also affected by at least one lahar. On the western side of Kandangan (~20 km north of the crater), the lahar was said

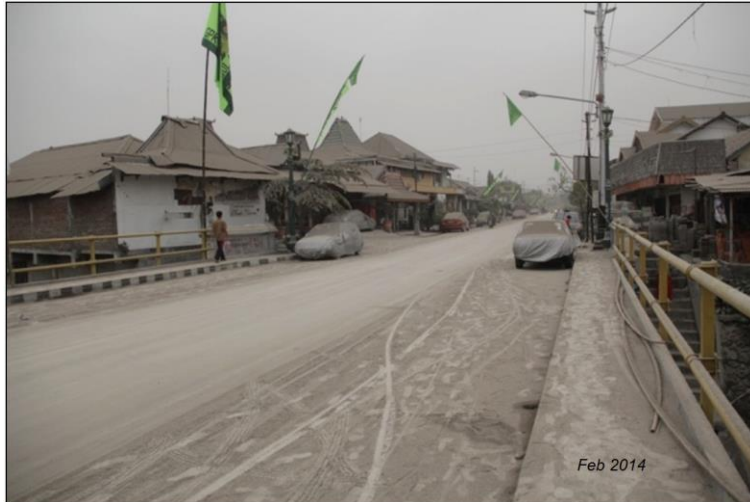
Figure 2.13 Cars at Castle Bridge, Yogyakarta covered in plastic protective sheeting (BPBD DIY 2014b).

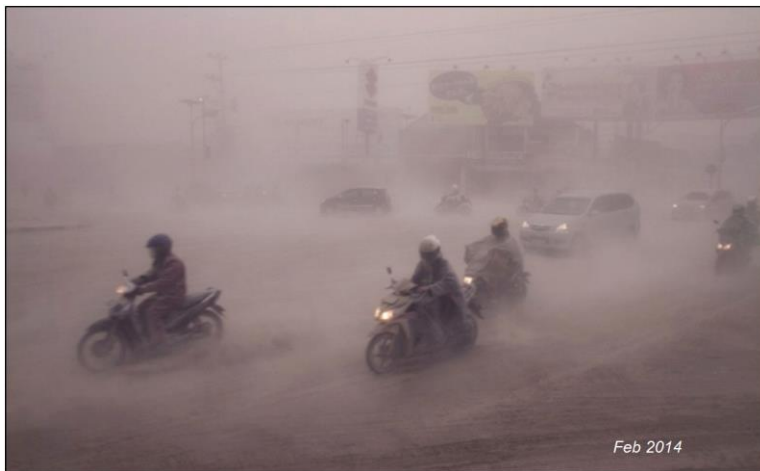
Figure 2.14 Motorbikes driving through ash in Yogyakarta (Washington Post 2014). Remobilisation of fine ash in the city meant that visual range was ~3 m at times.

In Yogyakarta, the government advised people to stay off roads and to only drive or go outside when absolutely necessary and to turn their lights on if they had to drive (BPBD DIY 2014a*, Mahjum (pers comm, 2014)*). Most people obeyed this advice and many were reluctant to drive in their vehicles anyway because of concerns about vehicle damage including scratched windows and engine problems, difficulties driving in ash and impacts on breathing and health (DJPD & DJPL 2014*). Some cars were covered in plastic sheeting as a protective measure (Figure 2.13) (BPBD DIY 2014b). As a result, the roads in Yogyakarta were relatively quiet for up to a week after the eruption (DJPD & DJPL 2014*, Irvine-Brown 2014, Mahjum (pers comm, 2014)*), although police were out helping to manage traffic flow (BPBD DIY 2014a*). Visibility in Yogyakarta was reduced to a visual range of just 1-3 m at times (BPBD DIY 2014a*, BPBD DIY 2014b, DJPD & DJPL 2014*). This was largely due to remobilisation from vehicles and worsened in areas where ash was thicker, making it difficult to drive

(Figure 2.14) (DJPD & DJPL 2014*). Outside of the city, visibility was also very low with a visual range of ~7 m near Borobudur Temple reported (Antara News 2014a).

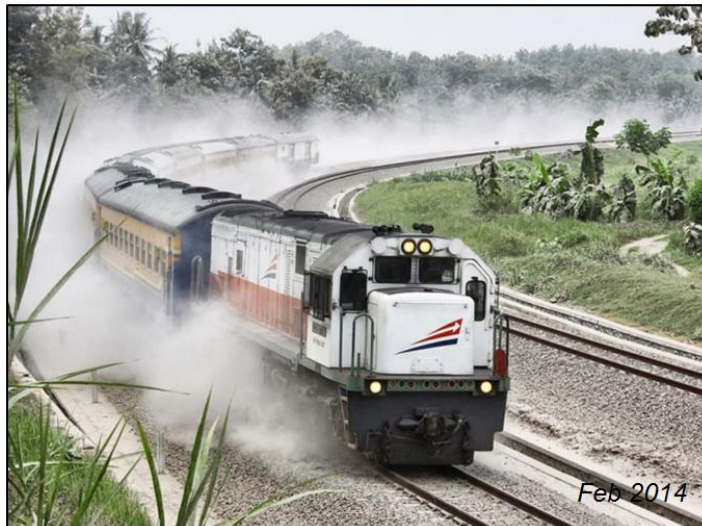
Figure 2.15 Surabaya to Bandung train passing through ash deposited at Kalimenur, Yogyakarta Special Region Province on 16 February 2014, over two days after the eruption (Habibie 2014).

Diesel trains run on all areas of the rail network that were impacted by ash from Kelud (the only electric trains in Java are found in Jakarta) (DJPD & DJPL 2014*). Although there was evidence of rail tracks becoming thinly covered in ash from the Kelud eruption (Figure 2.15), there were no reports of rail services being delayed or cancelled specifically due to ash impacts. This is difficult to monitor in Java as delays and cancellations are relatively frequent, especially to the economy class services. However, rail appears to have been the least affected transportation mode with BPBD DIY staff claiming that it was 'the only transportation sector able to penetrate volcanic ash disruption'.

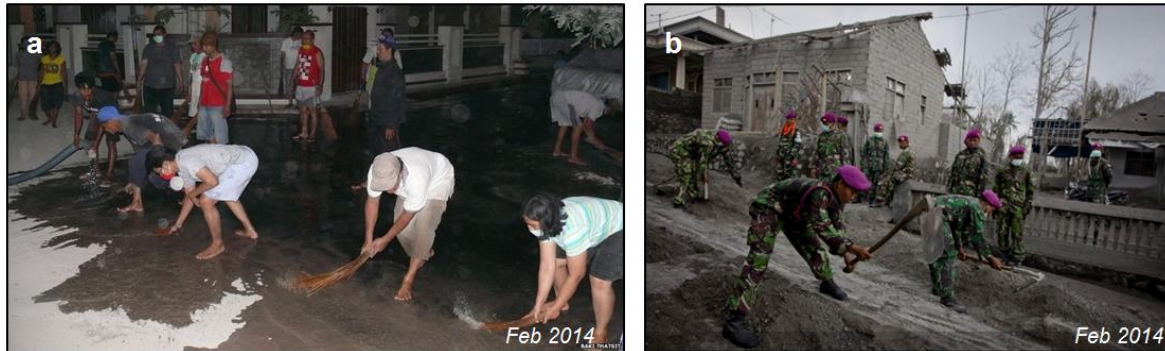
Figure 2.16 A coordinated approach to clean-up was adopted in many areas. (a) Residents cleaning a street together in the Kediri Regency (Irvine-Brown 2014). (b) TNI staff help to clear streets in Pandansari Village, Ngantang District, Malang Regency (Washington Post 2014).

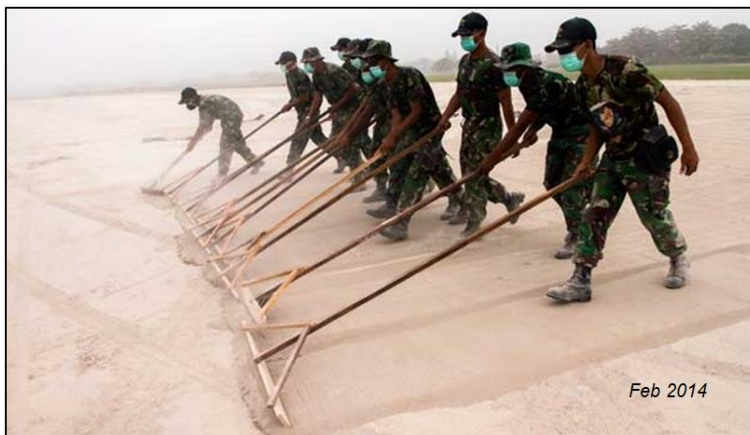
Figure 2.17 Clean-up using *ongsrok*, a common tool used for clean-up of ash consisting of a wooden pole and small plank of wood (Tempo.co 2014).

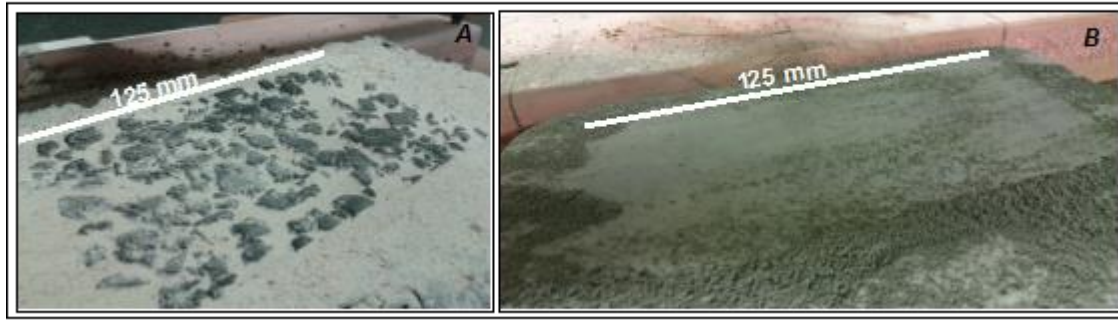
Figure 3.12 Dry ash displacement from the BPT slider-surface interface after 8x swings of the pendulum arm for (a) SMA, and (b) airfield concrete. Dry ash was displaced from the surface more readily than wet ash.

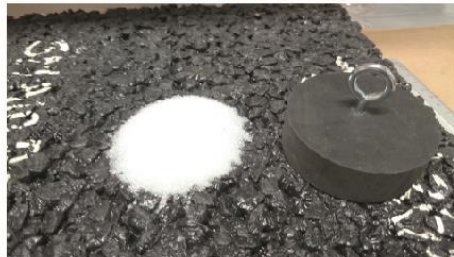
Appendix B4. Summary of sand patch volumetric technique used to calculate the average pavement macrotexture depth (adapted from ASTM E965 2006)

1. Pour glass beads (600-850 μm diameter and minimum 65% true spheres) up to a level on the cylinder which has a known volume.
2. Gently tap base of cylinder several times and add more glass beads to level.
3. Determine mass of material in cylinder (which is used for each measurement).
4. Pour measured volume and weight of material onto asphalt concrete surface.
5. Carefully spread material into circular patch with the rubber disk tool, filling the surface voids flush with the aggregate particle tips.
6. Measure and record the diameter of the circular area covered by the material at four equally spaced locations around the sample circumference.
7. Compute and record the average diameter.
8. Calculate average pavement macrotexture depth using equation (2).
